ESKIMO III. MAGAZINE SEPARATION TEST

# Eskimo III

## Magazine Separation Test

by  
Frederick H. Weals

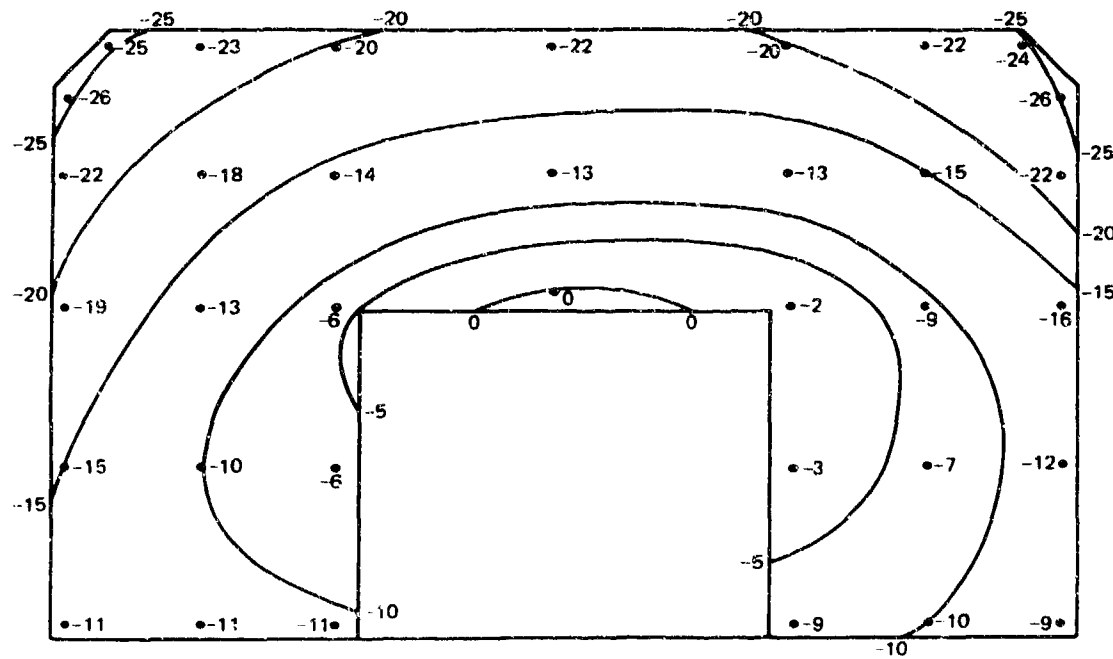
FIGURE 45. Headwall Movement, Igloo D. Minus values indicate movement outward, toward the donor; one point (above door) showed no movement. Units shown are hundredths of feet.

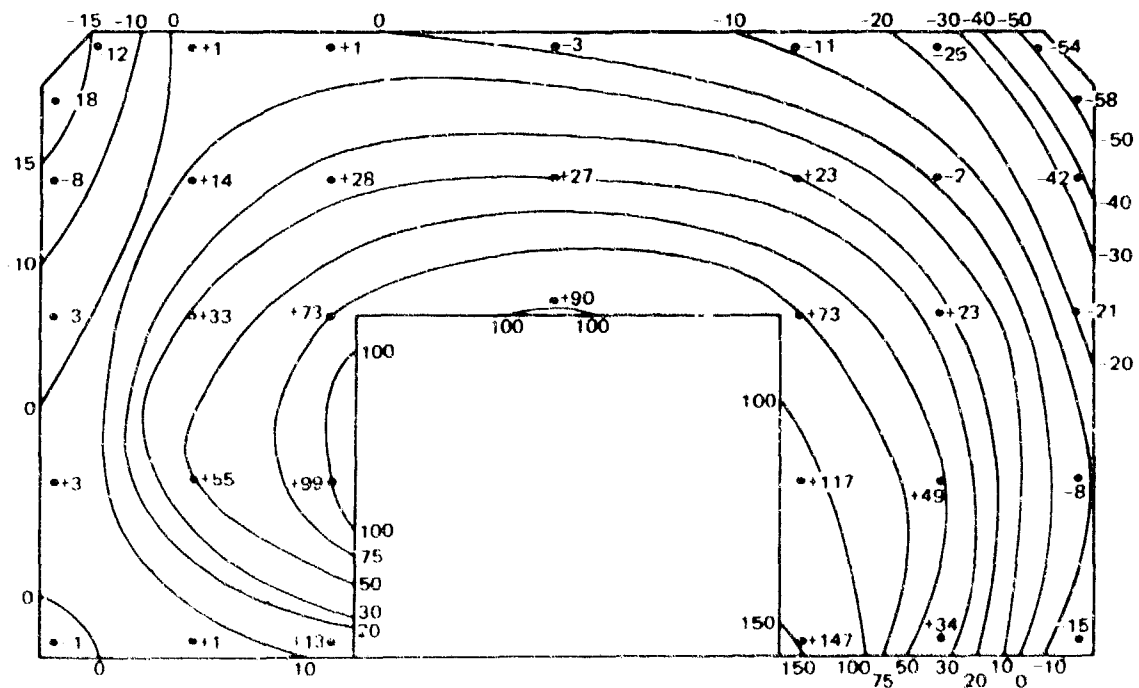
FIGURE 46. Headwall Movement of Acceptor Igloo E. Minus values show movement toward the donor, plus values, away from the donor. Units shown are hundredths of feet.

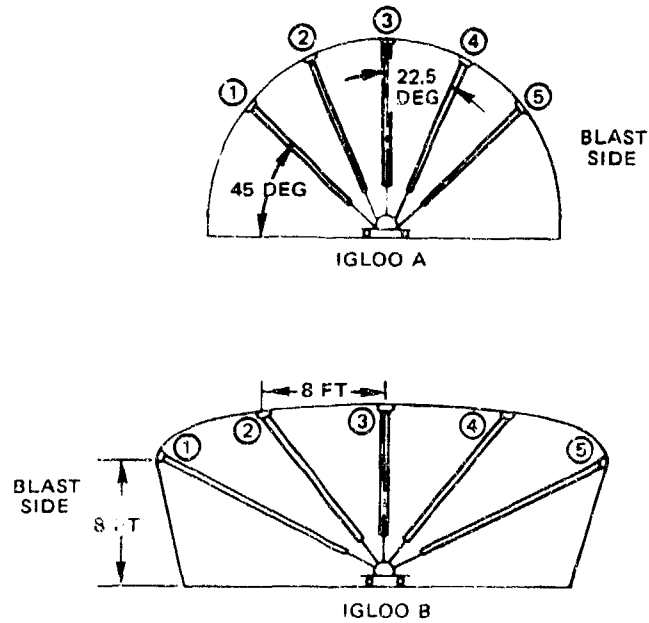
FIGURE 47. Position Key for Measurement of Arch Deformation.

Arch deformations were measured at a minimum of five positions each (Figure 47) at the forward one-quarter (20 feet in from the headwall), midsection or 40 feet in, and 60 feet in at the rear one-quarter section of Igloos A and B. Table 10 shows arch movement at these preselected points. Note that the movement is shown in absolute terms as well as relative to floor movement. Arch movements at points of maximum deformation are illustrated in Figure 48. Since these positions were not measured before the blast, the measurements are less reliable than those shown in Table 10.

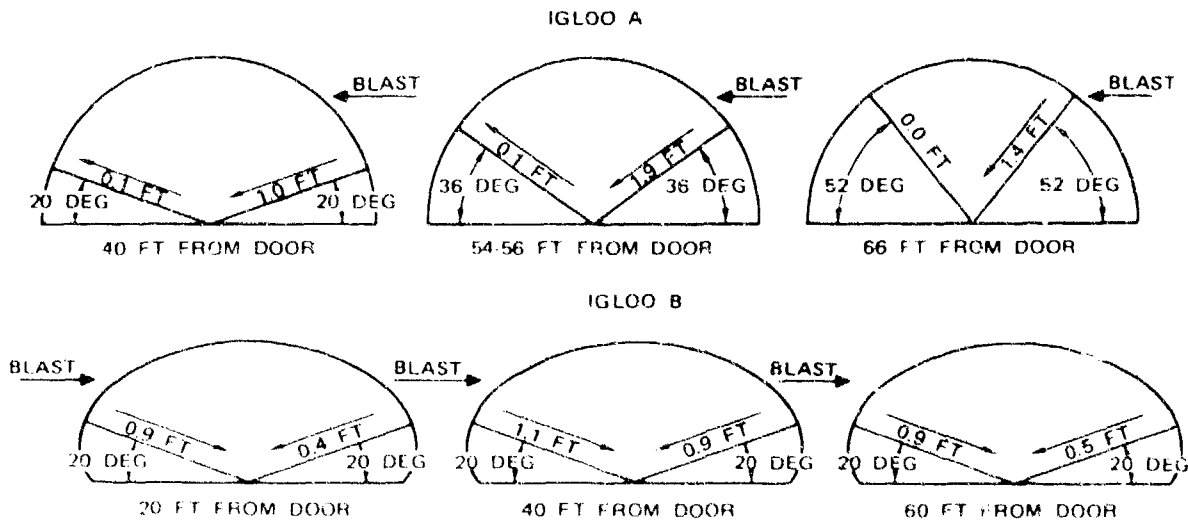
FIGURE 48. Maximum Static Arch Movements at Blast Side of Arch. Movements at corresponding positions on leeward side are also shown.

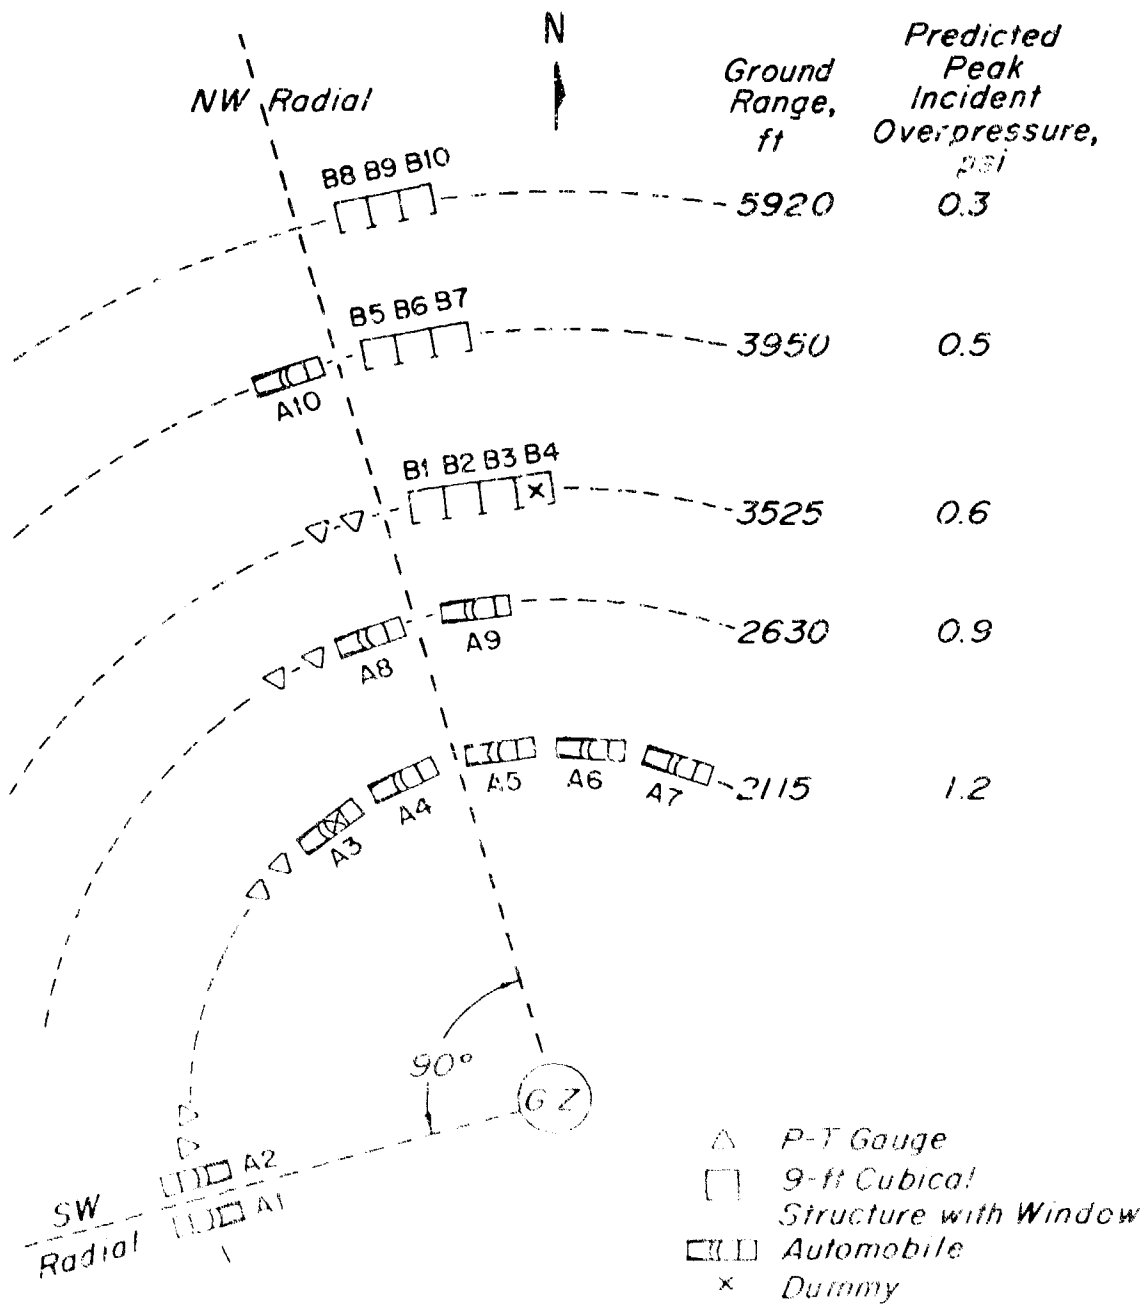
FIGURE 1. Car Field Layout for the Eskimo III Test

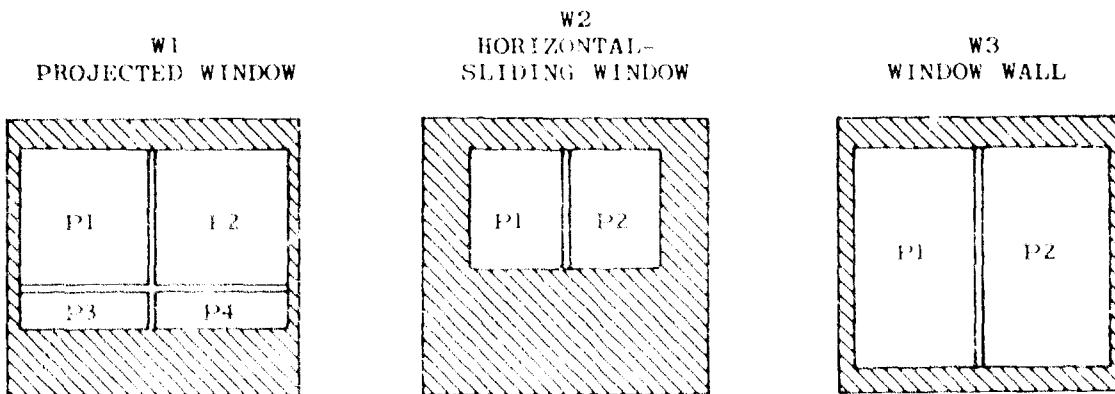
FRONT VIEW OF THREE MODULES INDICATING  
WINDOW TYPE AND PANE NUMBERS

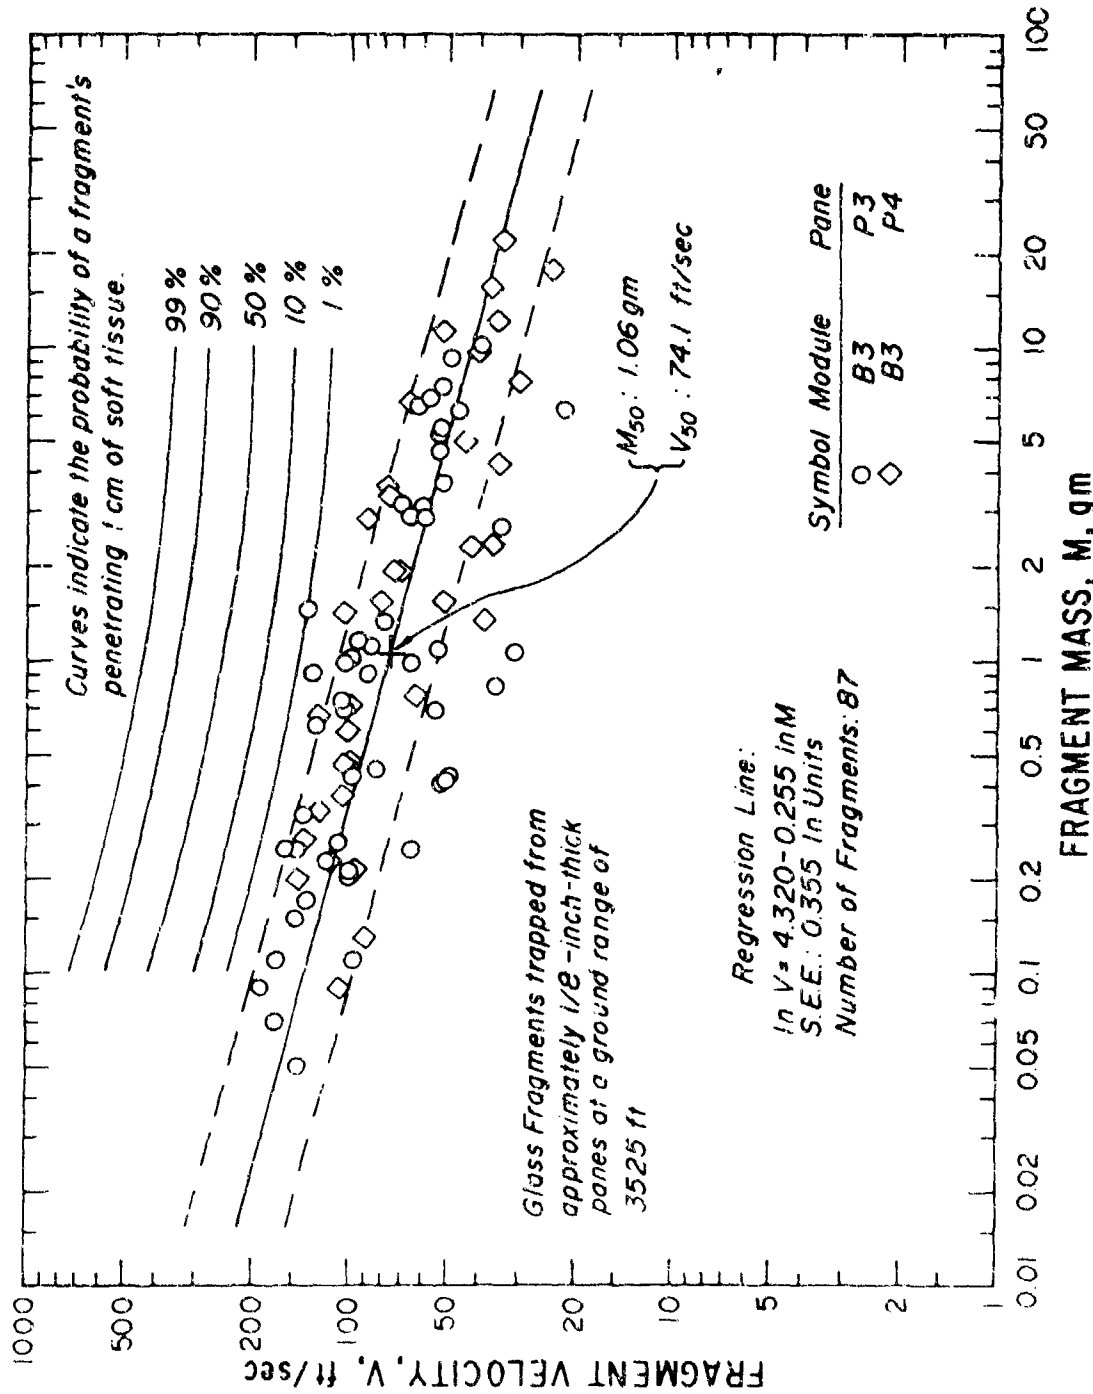
FIGURE 3. Glass Fragments Trapped From Approximately 1/8-Inch-Thick Panes at a Ground Range of 3,525 Feet.

combined into five groups (no 1/8-inch-thick fragments were trapped at 5,920 feet) representing panes approximately 1/4- or 1/8-inch-thick located at the 3,525-, 3,950-, or 5,920-foot ground range. These groups are shown in Figures 3 through 7 which contain regression lines as well as lines drawn one standard error of estimate on either side of the regression lines. The results of the regression analysis for each of the five groups are given in Table II where it can be noted that the mean fragment velocity estimated from the motion-picture record obtained at 3,525 feet was 29 ft/sec compared to 37.6 ft/sec measured from the witness plate behind a similar pane in module B1 at the same range.

Figures 3 through 7 contain curves indicating the probability of a fragment's penetrating 1 cm of soft tissue as given in Reference 4. It can be seen that, of the 267 trapped fragments for which masses and velocities are available, only three had at least a 1.0-percent probability of penetrating 1 cm of soft tissue. All three occurred at the 3,525-foot range where fragments were trapped behind eight panes, giving an average of about one fragment for each two panes with a significant (at least

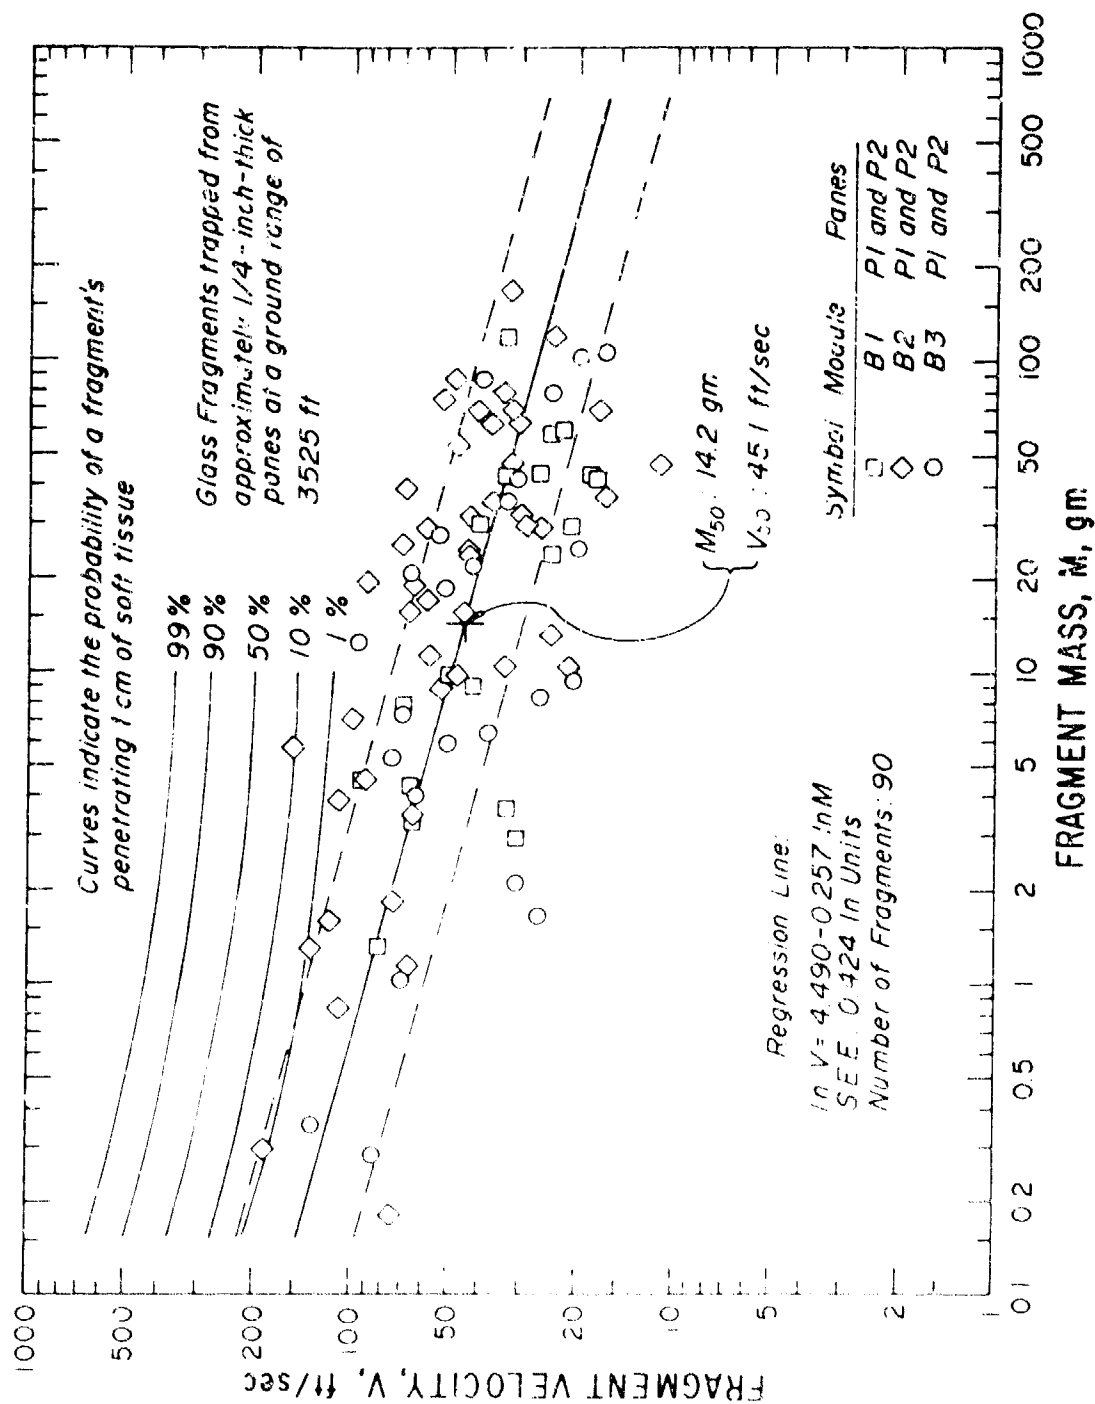
FIGURE 4. Glass Fragments Trapped From Approximately 1/4-Inch-Thick Panes at a Ground Range of 3,525 Feet.

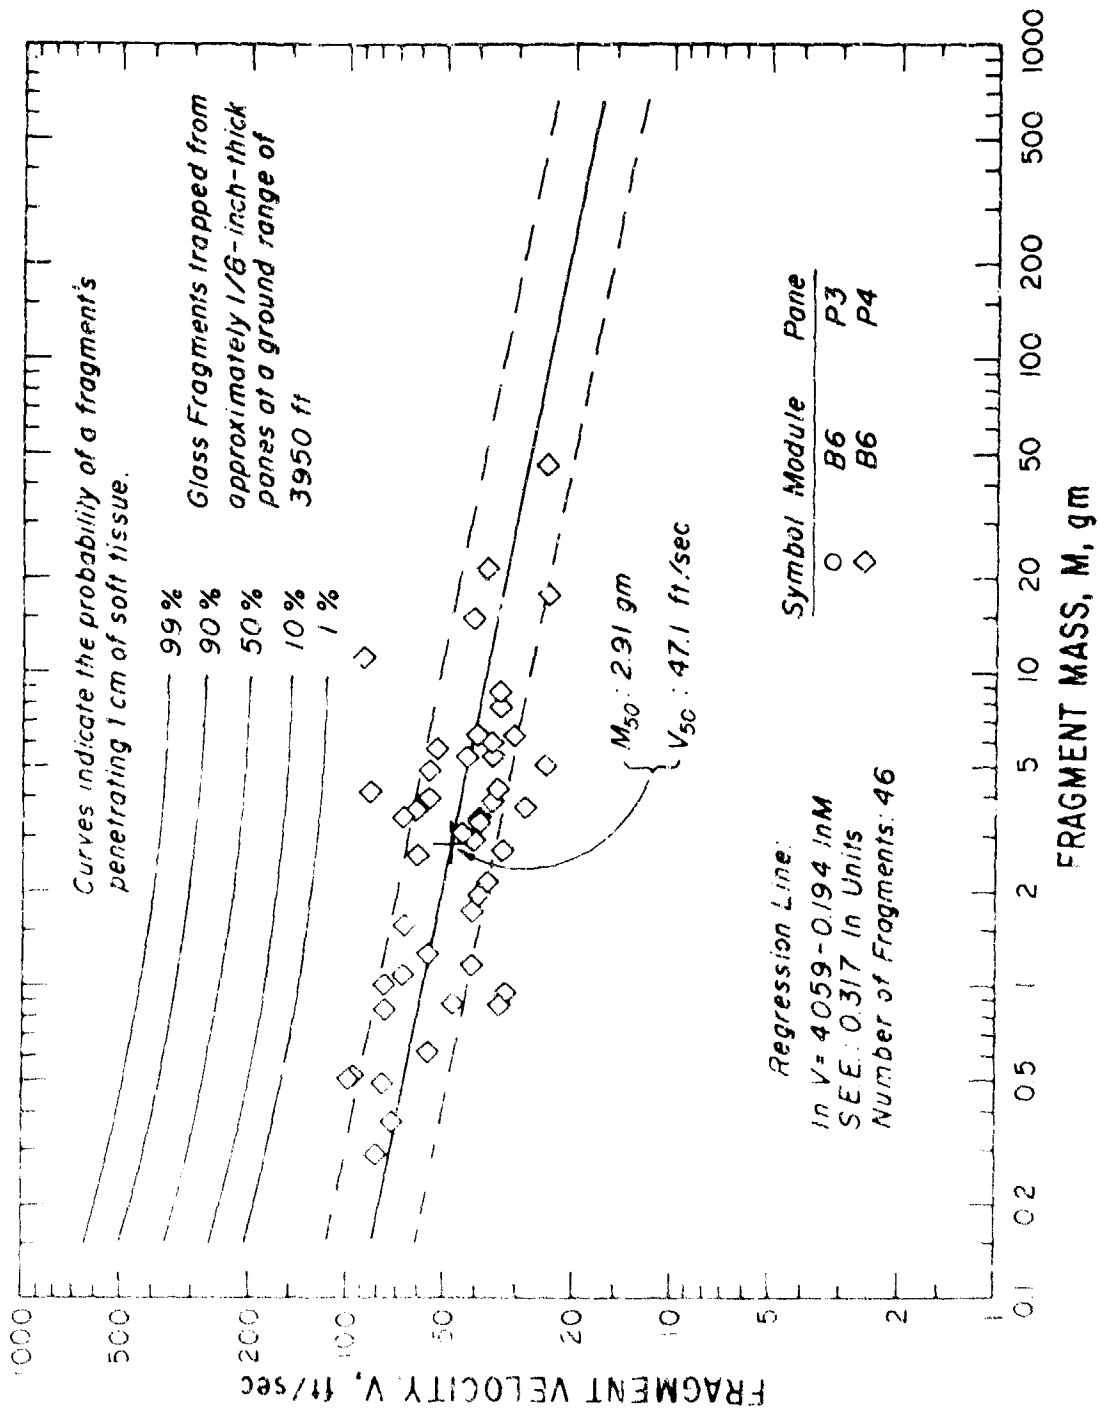
FIGURE 5. Glass Fragments Trapped From Approximately 1/8-Inch-Thick Panes at a Ground Range of 3950 Feet.

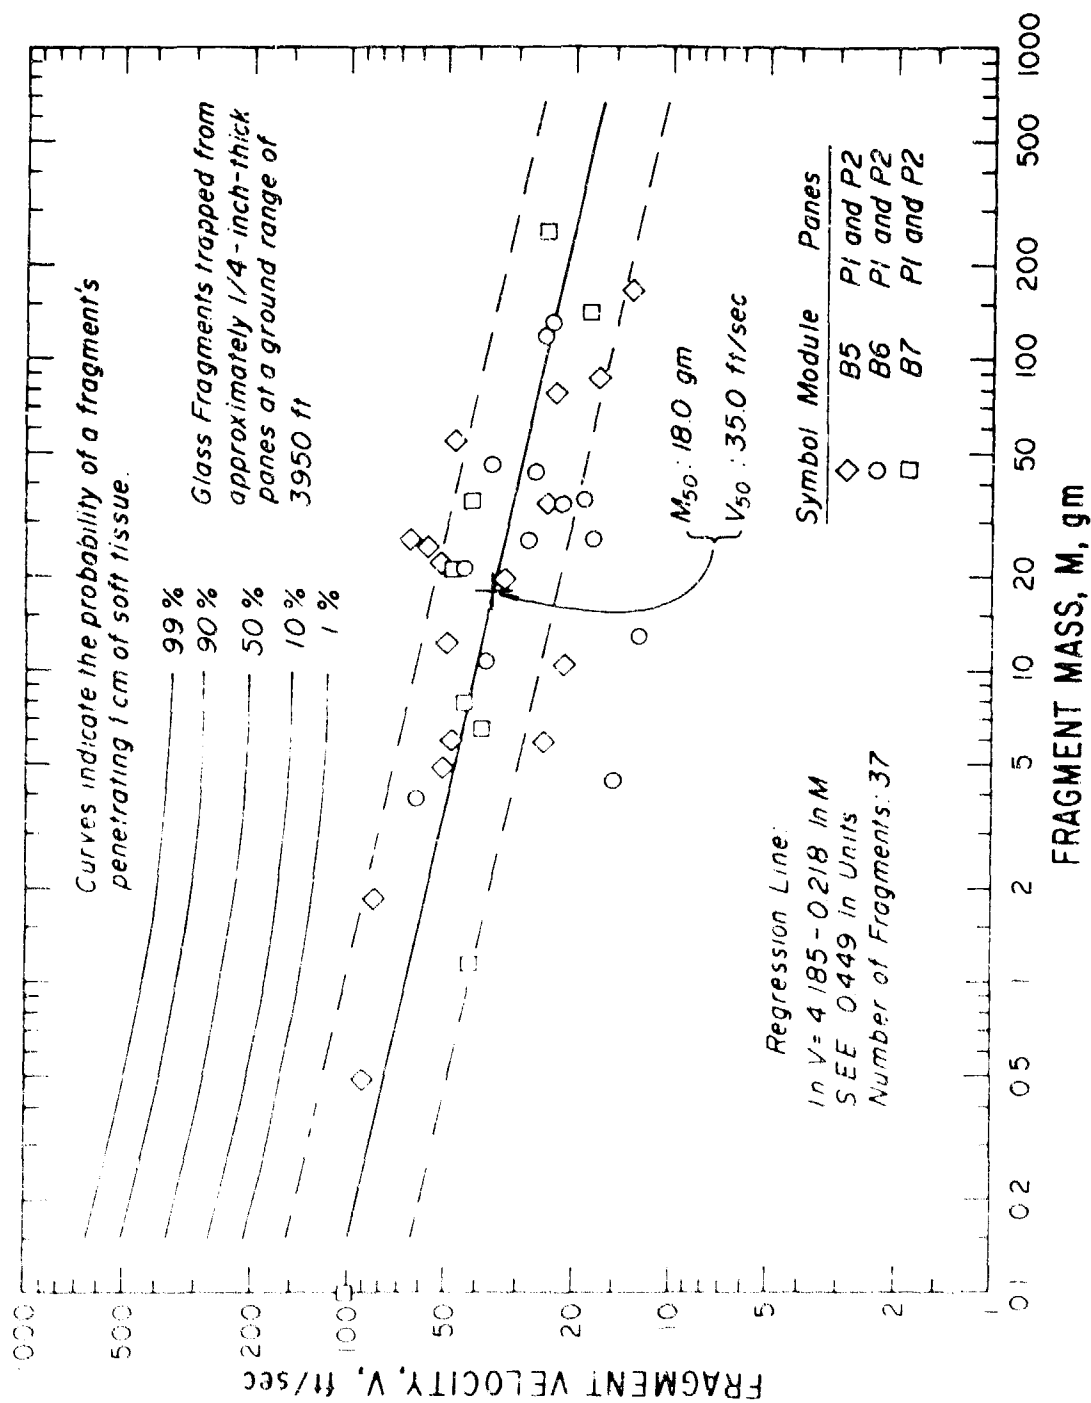
FIGURE 6. Glass Fragments Trapped from Approximately 1/4-Inch-Thick Panes at a Ground Range of 3950 Feet.

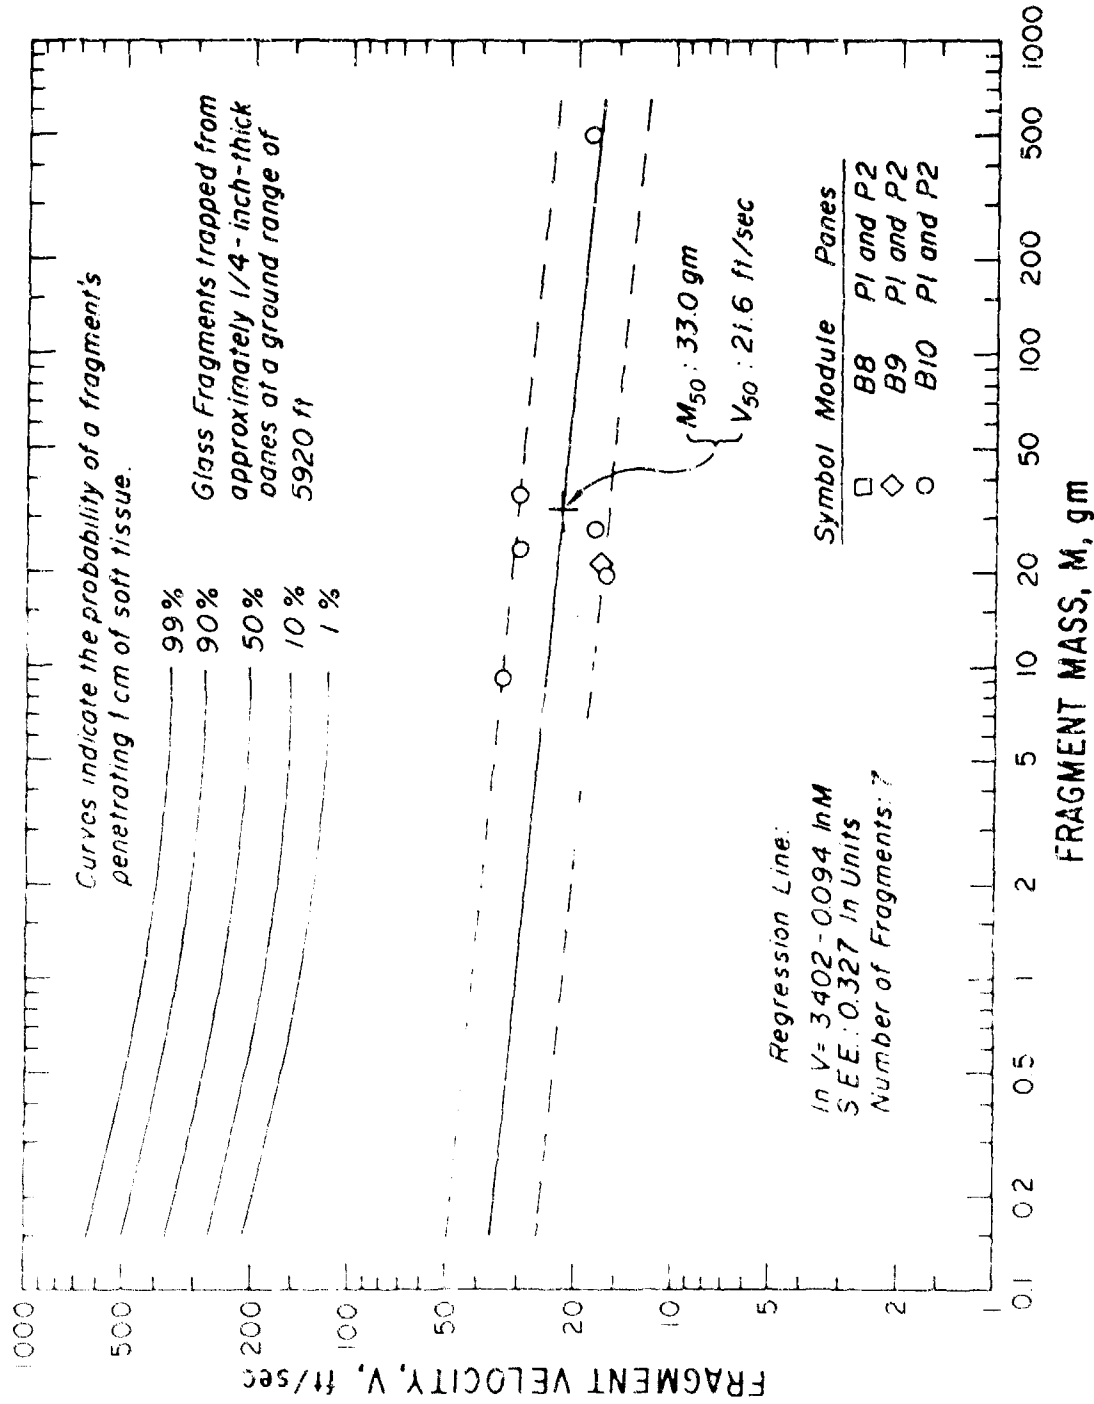
FIGURE 7. Glass Fragments Trapped from Approximately 1/4 Inch-Thick Panes at a Ground Range of 5920 Feet.

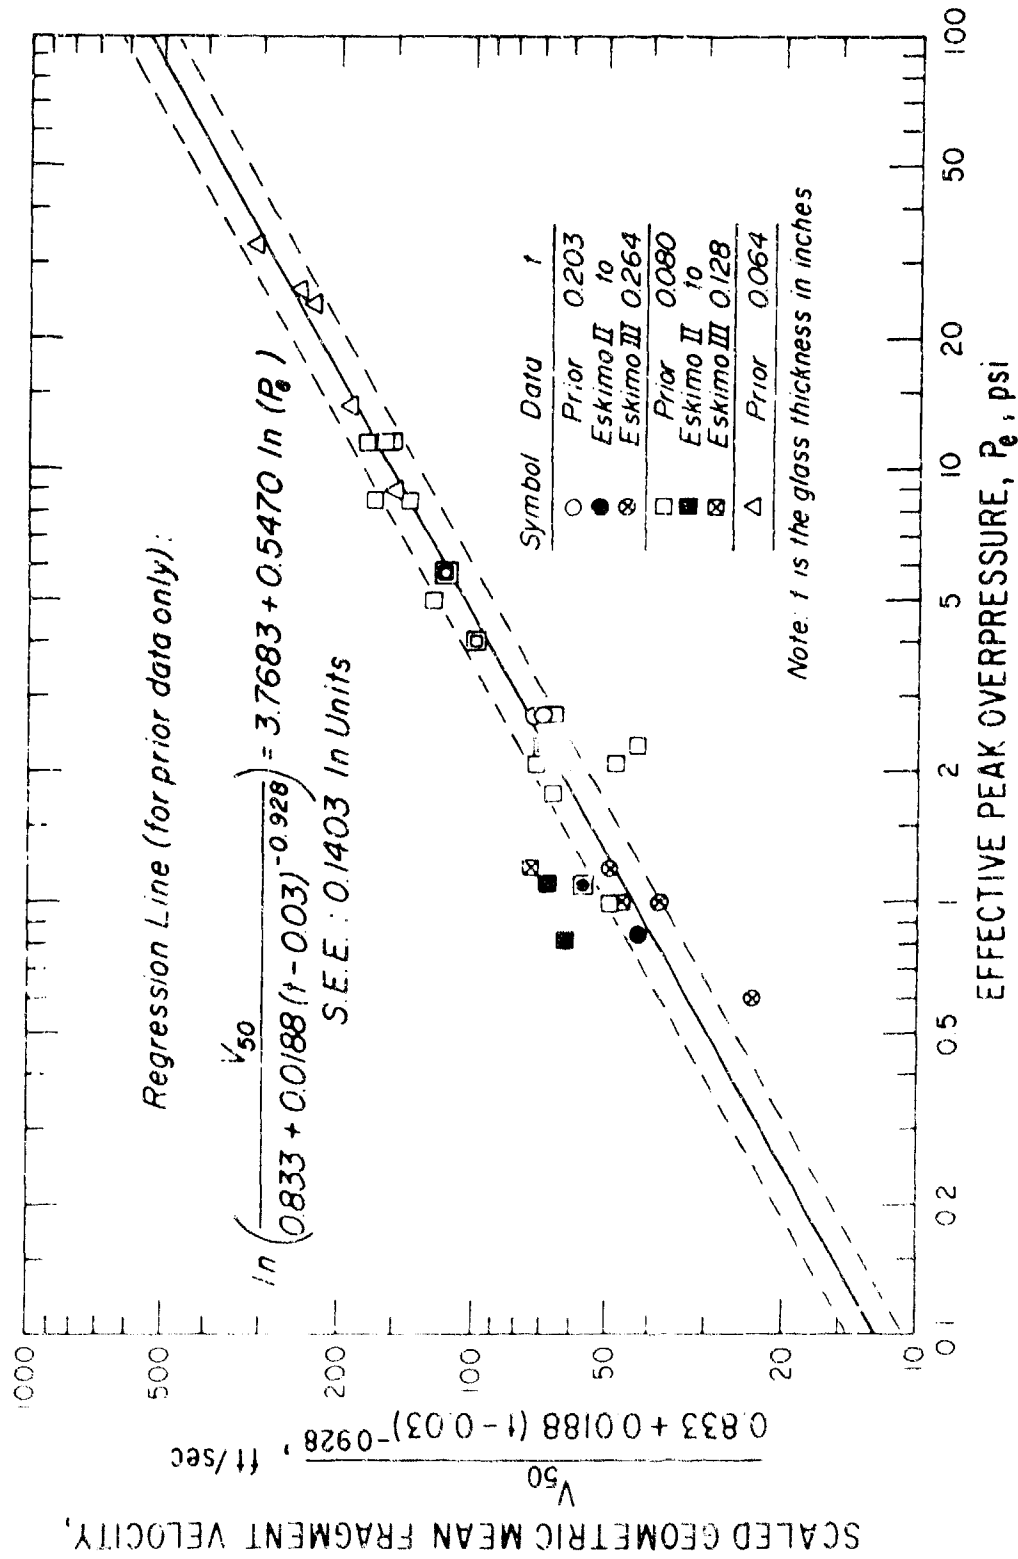
FIGURE 8. Scaled Geometric-Mean Fragment Velocity Versus Effective Peak Overpressure.

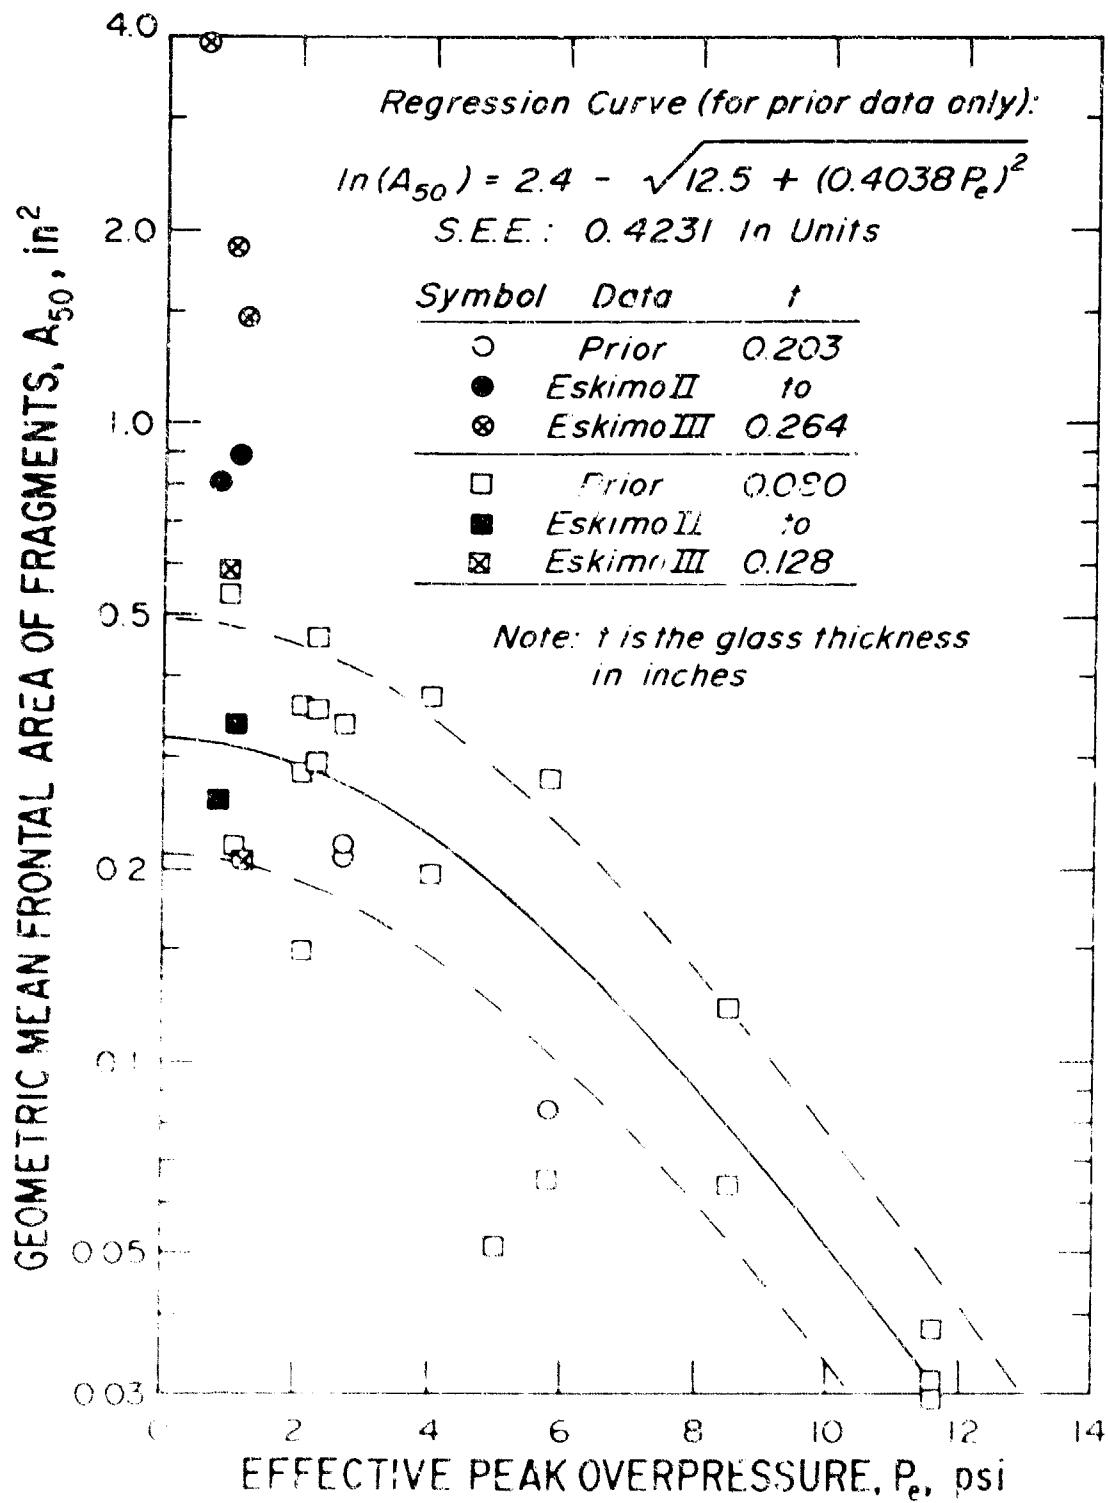
FIGURE 9. Geometric Mean Frontal Area of Fragments Versus Effective Peak Overpressure

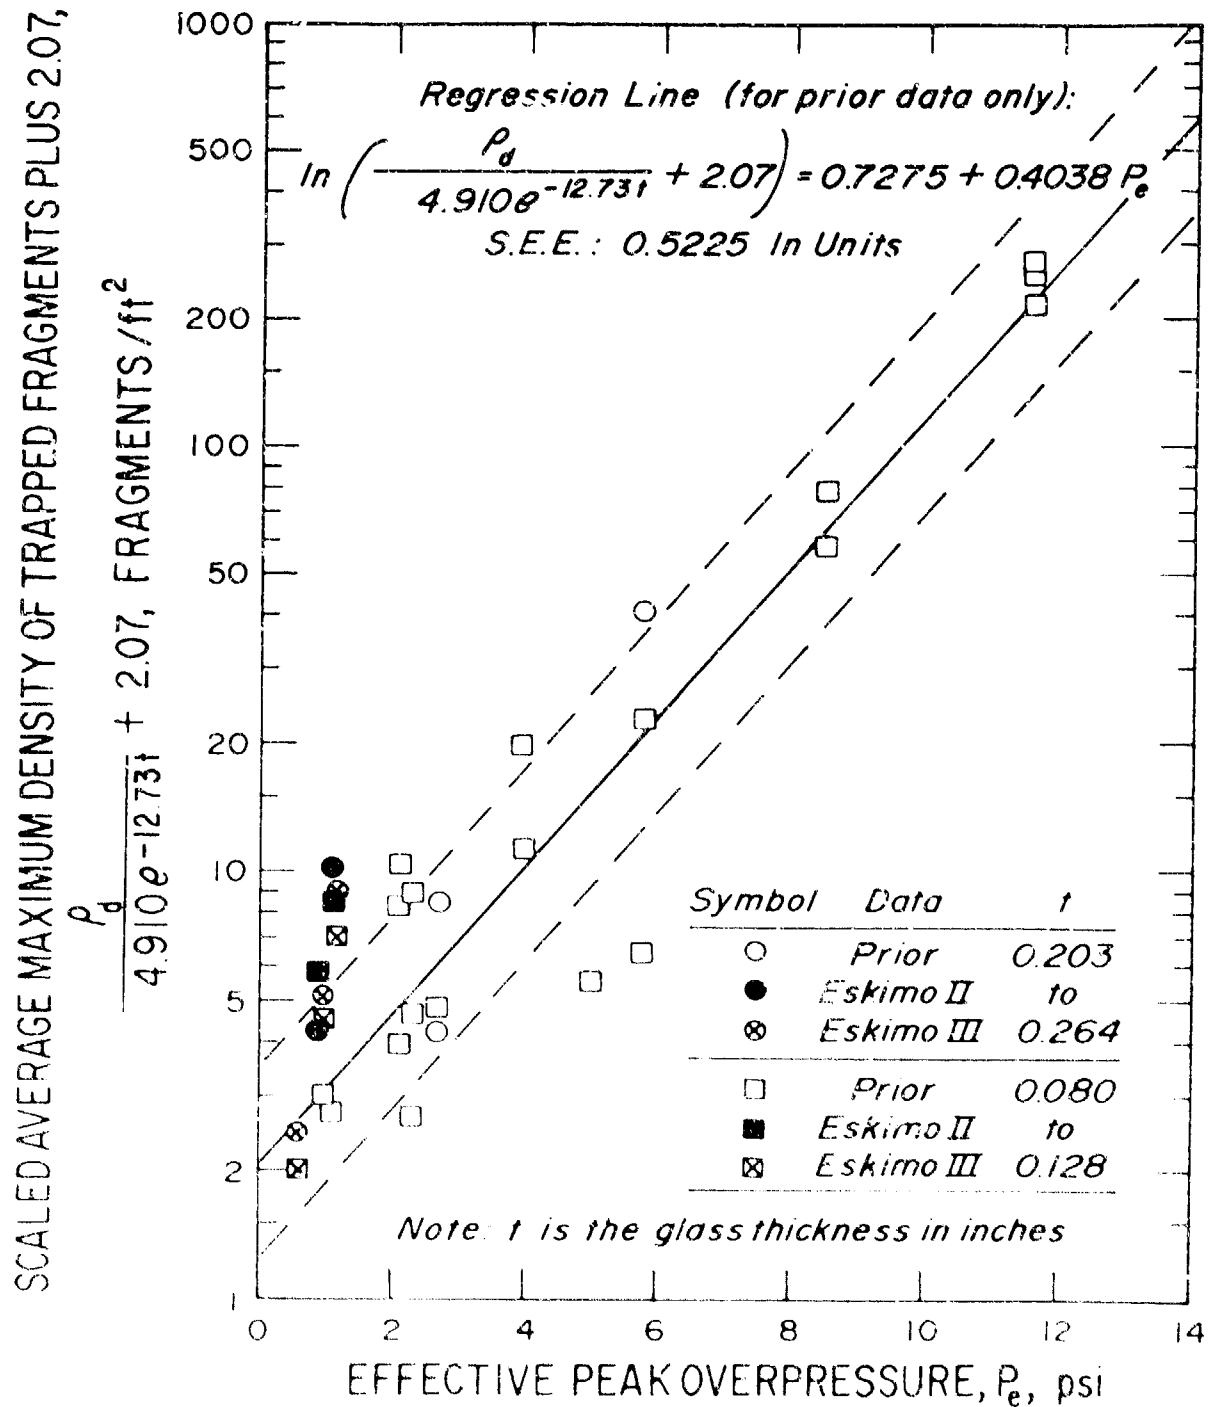
FIGURE 10. Scaled Average Maximum Density of Trapped Fragments Plus 2.07 Versus Effective Peak Overpressure
